PRELIMINARY NONDESTRUCTIVE EVALUATION MANUAL FOR THE SPACE SHUTTLE

**PRELIMINARY NONDESTRUCTIVE EVALUATION MANUAL
FOR THE SPACE SHUTTLE**

APPENDIX TO FINAL REPORT

**LOCKHEED-GEORGIA COMPANY
A DIVISION OF LOCKHEED AIRCRAFT CORPORATION
MARIETTA, GEORGIA 30063**

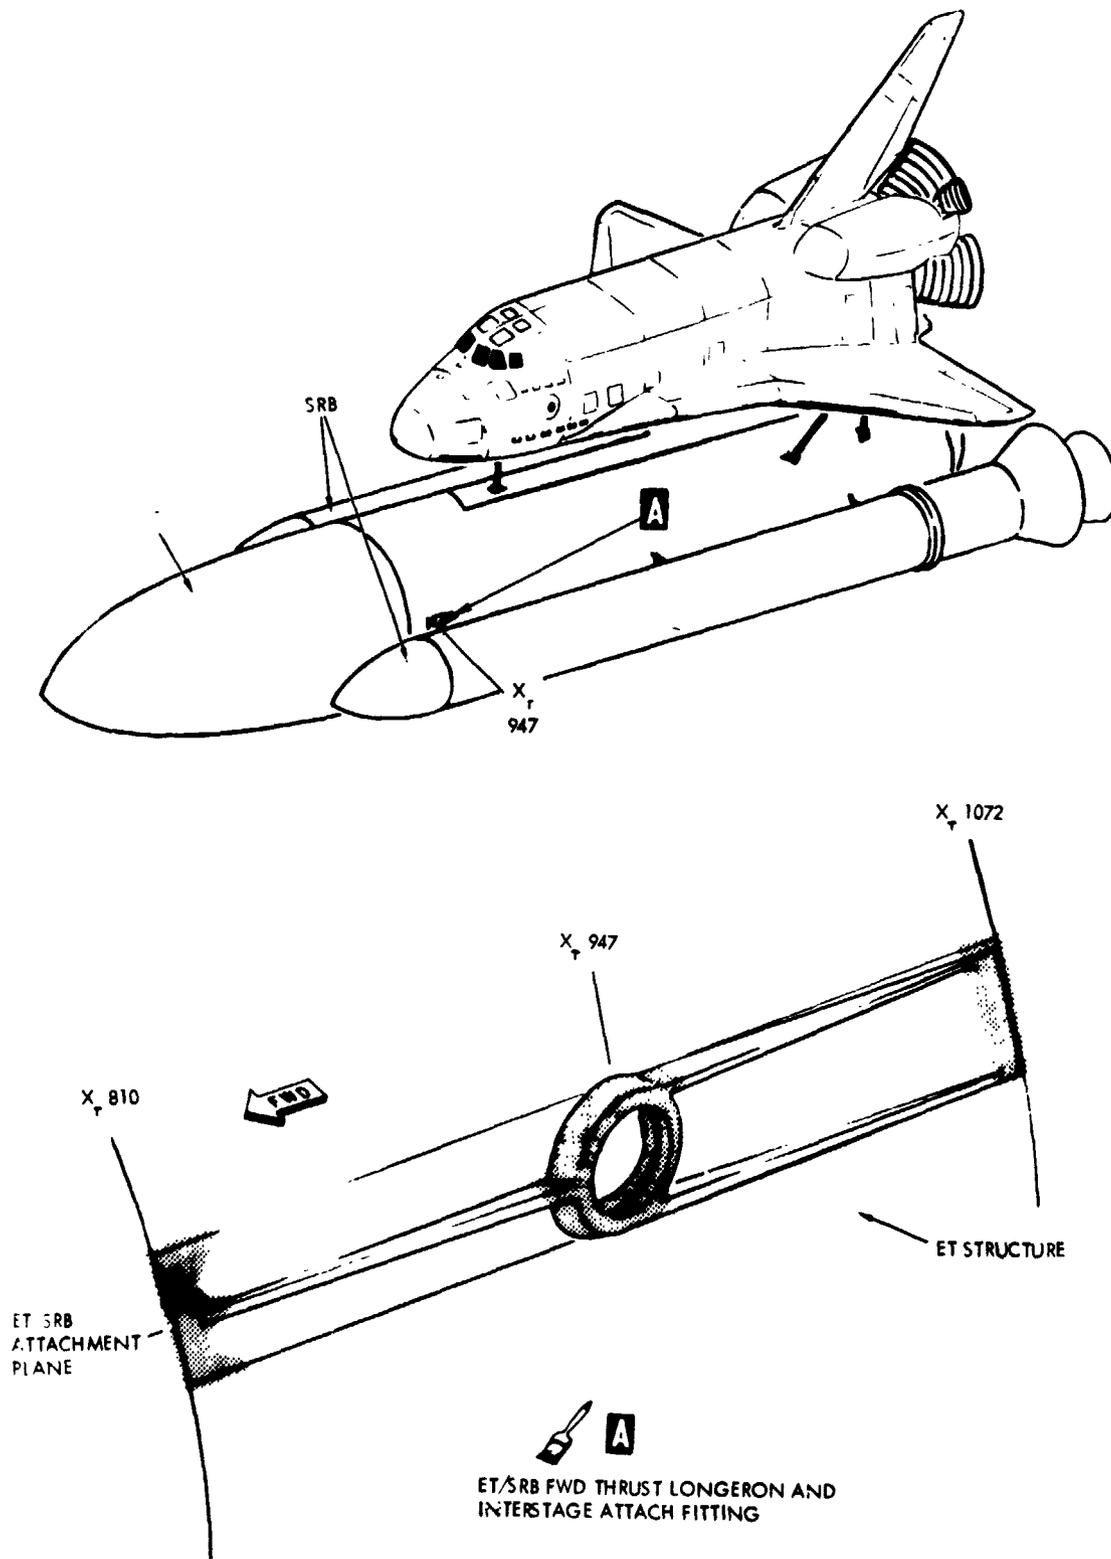
Figure 7-1. ET/Orbiter Forward Attachment Fitting and Thrust Longeron

FITTING. There are two fittings located on the ET at X_f 1078, Z_f 558 and $Y_f \pm 46.5$. They are machined from Ti-5Al-2.5Sn titanium. The fitting reacts intervehicle loads between ET and Orbiter resulting from static and G-loads, vibro-acoustics, aerodynamics, wind buffeting and maneuver loads. Since the ET is not recovered after launch for reuse, flight damage is of no concern (for refurbishment considerations). However, sustained static loads and wind exposure for an excessive time on the launch pad may result in fatigue damage and the fitting should be inspected prior to launch.

DEFECTS: Cracks in the fitting lug attachment hole and in the fillet where the lug blends into the base of the fitting.

This safe-life 7075-T73 aluminum alloy forging receives the SRB thrust loads and, via the ET/SRB attach fitting at station X_f 947, transfers them into the ET intertank frames and skin. The longeron experiences high tensile loads during thrust buildup and acceleration to maximum "G" loads. Since the ET is not recovered for reuse after a launch cycle, flight damage is of no concern for refurbishment. However, static fatigue and corrosion damage may occur to the mated Shuttle vehicles during mating or while the vehicle rests on the launch pad. In the event that the Shuttle remains mated on the launch pad for an excessive time or experiences high pre-launch wind gusts, the longeron and ET/SRB attachment fitting should be inspected.

DEFECTS: Transverse cracks in the longeron radiating from the ET/SRB attachment boss, and transverse cracks at fastener holes at frame attachment stations.

ACCESS: The longeron is accessible from outside the ET by the use of booms and from inside the ET intertank area. Enter the ET through the intertank access opening.

NDT TECHNIQUES: Primary: Fluorescent penetrant (Para. 1.5.2.1, Fig. 1-9) for ET/SRB attach area. Eddy current (Para. 1.5.4.4) or radiography (Para. 1.5.6.2) for frame-longeron attach areas.
Backup: Fluorescent penetrant (Para. 1.5.2.1, Fig. 1-4) for frame-longeron areas.

PROCEDURE NO: 7-801, FIGURE 7-1
MAJOR ASSEMBLY: EXTERNAL TANK, ZONE 8
SUBASSEMBLY: FORWARD ATTACHMENT
INTERFACE

PROCEDURE NO: 7-802, FIGURE 7-1
MAJOR ASSEMBLY: EXTERNAL TANK, ZONE 8
SUBASSEMBLY: FWD SRB/ET ATTACH
INTERFACE
DRAWING(S): VL78-000024, VL72-00103A

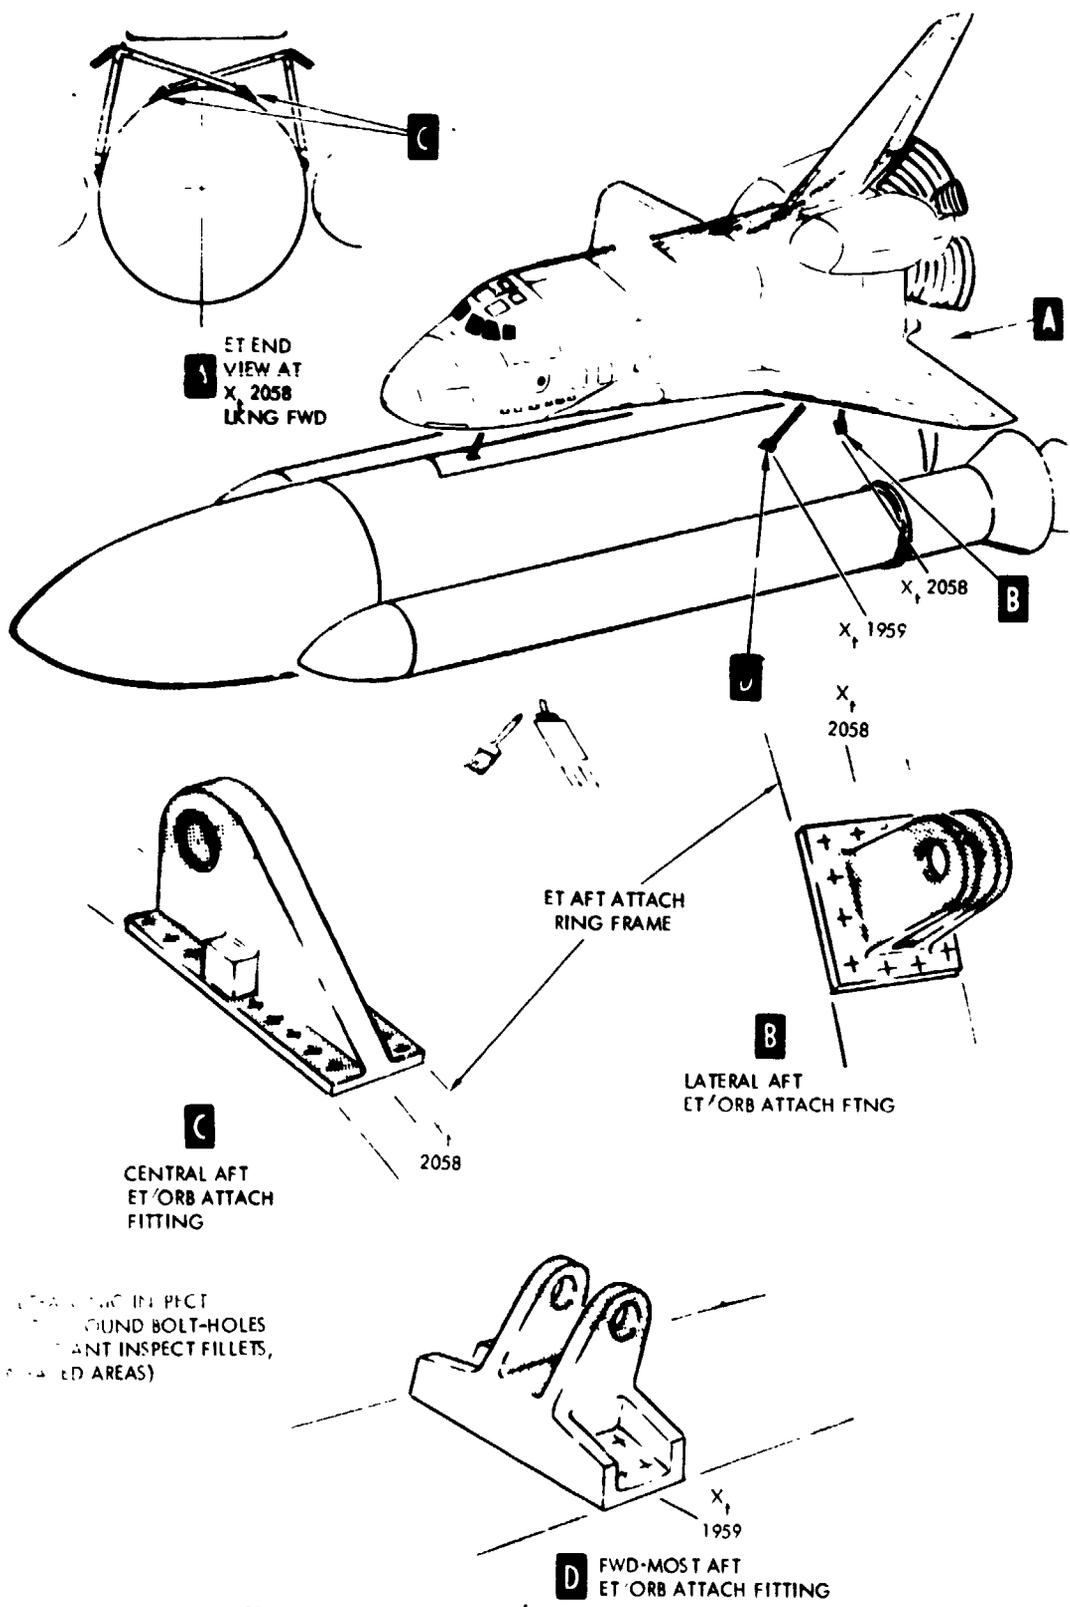
Figure 7-3. Aft ET/Orbiter Attach Fittings

COMPONENT/AREA DESCRIPTION: AFT ET/ORB ATTACH FITTINGS. The external tank contains six fittings along the aft ring frame at X_f 2058 and the support longeron extending from X_f 1959 to X_f 2058, where truss attachments are made to the Orbiter aft attach trusses. These titanium fittings contain clevis attachments to the trusses and have flange attachments to the ET frame structure. The fittings are subjected to tensile, compressive and shear loadings due to G-forces and intervehicular flight loads during lift-off and ascent. The fittings must be free of significant defects during this crucial period. Sustained static fit-up loads and wind gusts while on the launch pad may produce damage in the lug or flange attach areas and should be inspected prior to liftoff in the event of high winds and/or excessive launch hold.

DEFECTS: Radial cracks in the clevis lug bolt holes and cracks in the lug-to-base fillets.

ACCESS: Accessible from outside ET and Orbiter. Requires boom and work platform for proper elevation.

NDT TECHNIQUES: Primary: Ultrasonic shear wave (Para. 1.5.5.3 B) for lug bolt hole, fluorescent (Para. 1.5.2.1, Fig. 1-9) for other areas.
Backup: Eddy current bolt hole (Para. 1.5.4.3) for lug bolt hole.

PROCEDURE ID: 7-804, FIGURE 7-3
MAJOR ASSEMBLY: EXTERNAL TANK, ZONE 8
SUBASSEMBLY: AFT ET/ORB INTERFACE
DRAWING(S): VL72-000103A, VL72-000009, VL78-000024

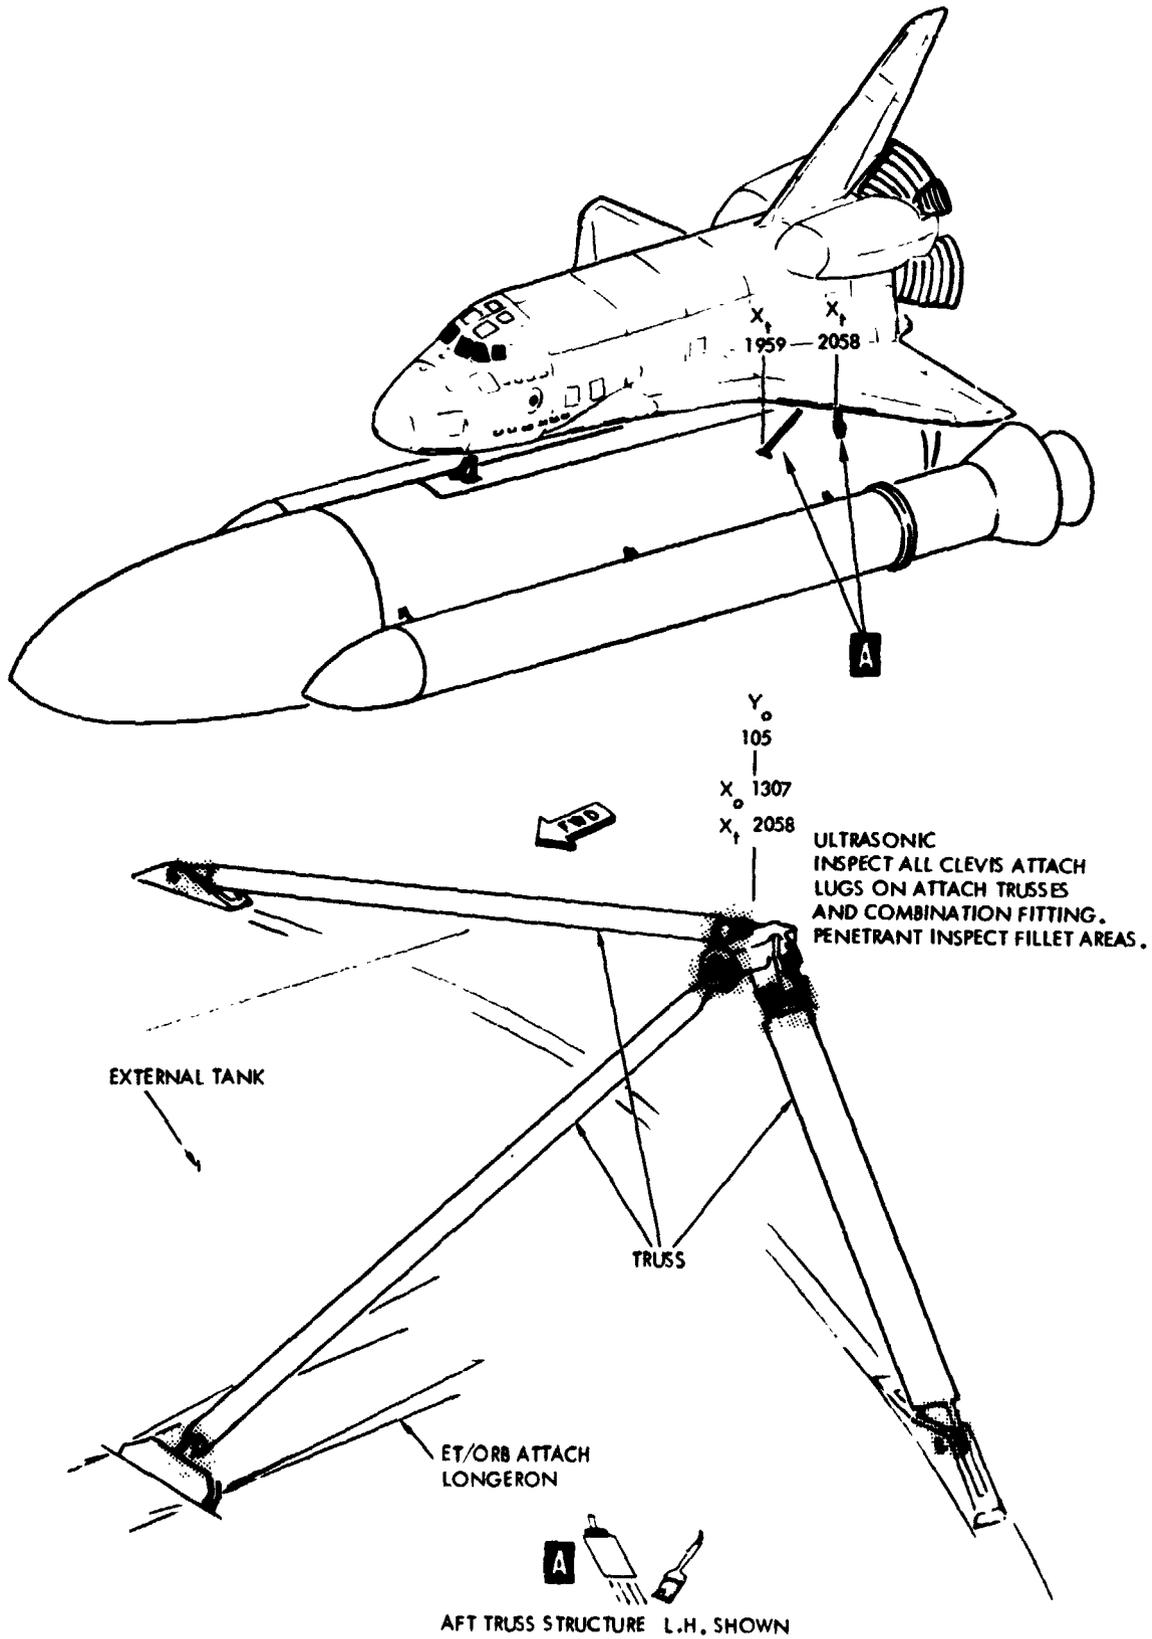
Figure 7-4. Aft ET/Orbiter Attach Trusses

COMPONENT/AREA DESCRIPTION: AFT ET/ORB ATTACH TRUSSES. The six ET clevis attach fittings mate with titanium (5Al-2.5Sn) truss tubes that interconnect the ET and Orbiter. The trusses receive high tensile and compressive flight loads during lift-off and ascent. The trusses must be free of significant defects during this crucial period. Sustained static fit-up loads and wind gusts while on the launch pad may produce damage in the end attachments of the truss tubes. In the event of high pre-launch winds and/or excessive launch hold the trusses should be inspected prior to launch.

DEFECTS: Radial cracks in the clevis and attachment areas and the multi-truss attachment fittings at the Orbiter attachment area.

ACCESS: The truss inspection areas are accessible from outside the ET and Orbiter. A boom and work platform will be required for proper elevation on the launch pad.

NDT TECHNIQUES: Primary: Ultrasonic shear wave (Para. 1.5.5.3 B) for clevis attach bolt holes; fluorescent penetrant (Para. 1.5.2.1, Fig. 1-9) for the multi-truss attach fitting.
Backup: Eddy current bolt hole (Para. 1.5.4.3).

PROCEDURE NO: 7-805, FIGURE 7-4
MAJOR ASSEMBLY: EXTERNAL TANK, ZONE 8
SUBASSEMBLY: AFT ET/ORB INTERFACE
DRAWING(S): VL72-000103A, VL72-000009,
VL78-000028

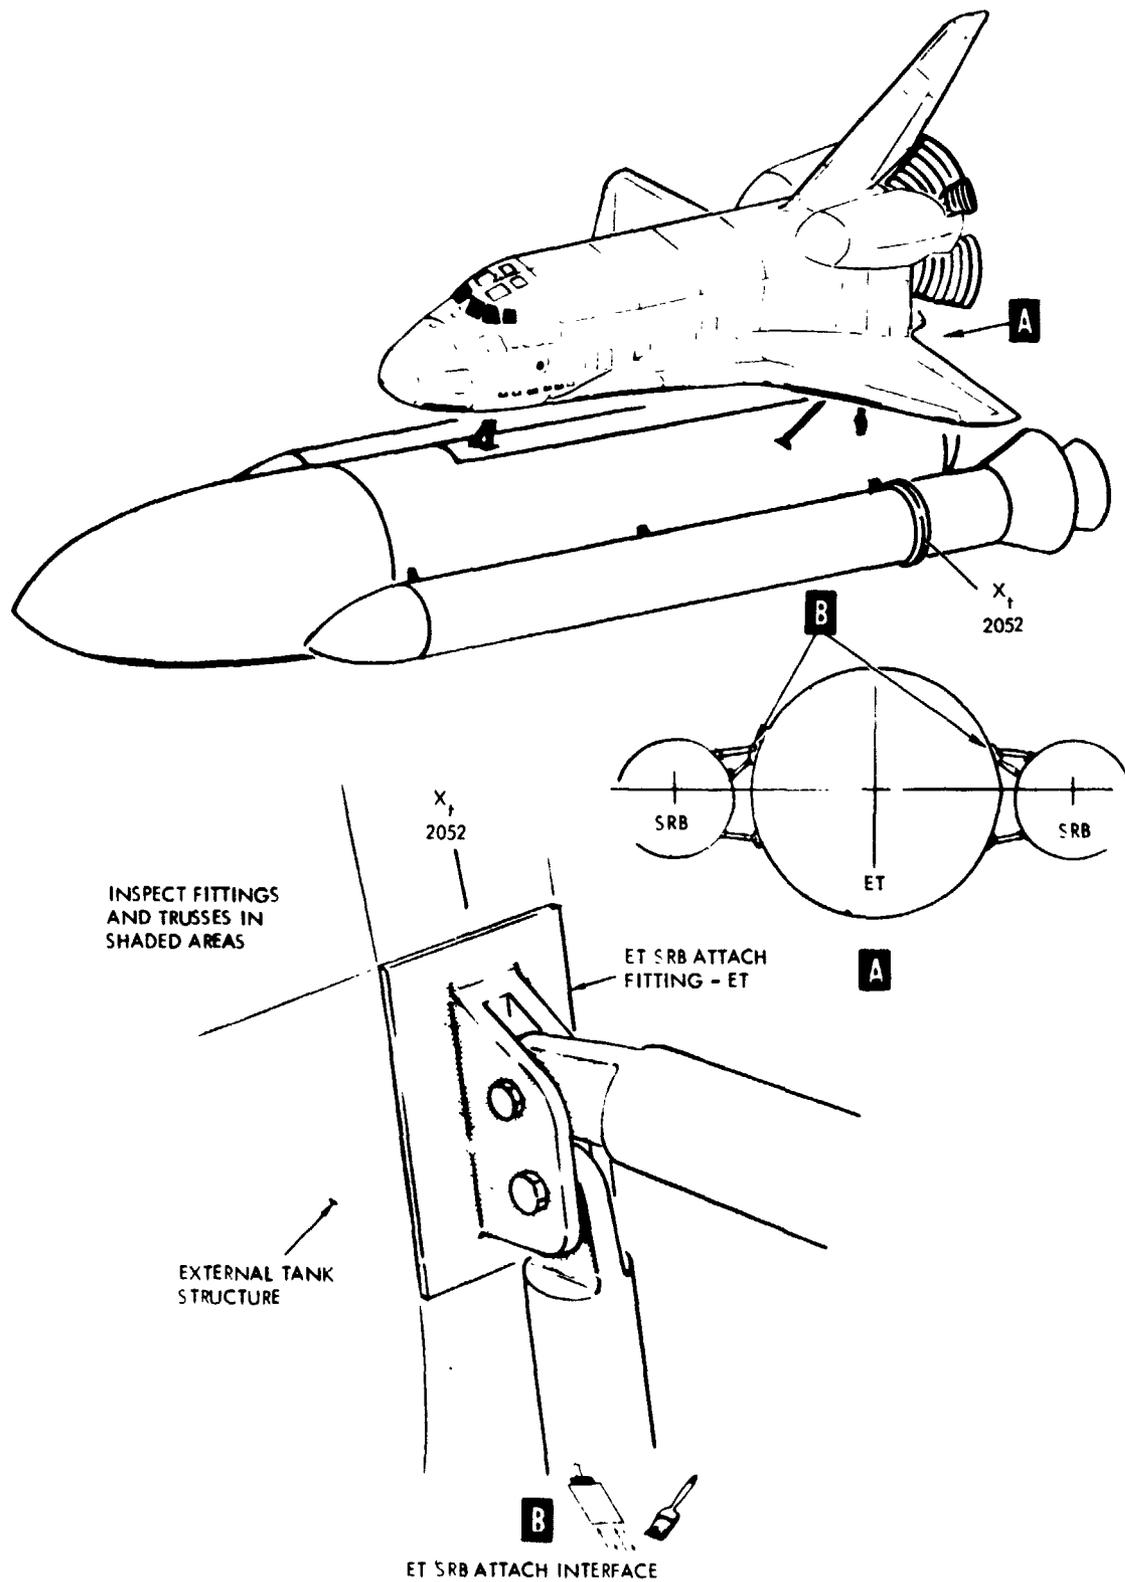
Figure 7-5. ET/SRB Aft Attach Fittings

DEFECTS: While subjected to high static and wind loads on the launch pad, cracks may occur at the bolt holes or in the fillet where the lug blends into the base.

ACCESS: Access is readily attained by the use of platforms or booms while the Shuttle is in the vertical launch attitude.

NDT TECHNIQUES: Primary: Ultrasonic shear wave (Para. 1.5.5.3 B) and fluorescent penetrant (Para. 1.5.2.1, Fig. 1-9).
Backup: Eddy current bolt hole (Para. 1.5.4.3) or fluorescent penetrant (Para. 1.5.2.1, Fig. 1-9) for attach hole.

PROCEDURE NO: 7-806, FIGURE 7-5
MAJOR ASSEMBLY: EXTERNAL TANK, ZONE 8
SUBASSEMBLY: AFT ATTACHMENT INTERFACE
DRAWING(S): VL72-000103A, VL78-000024A

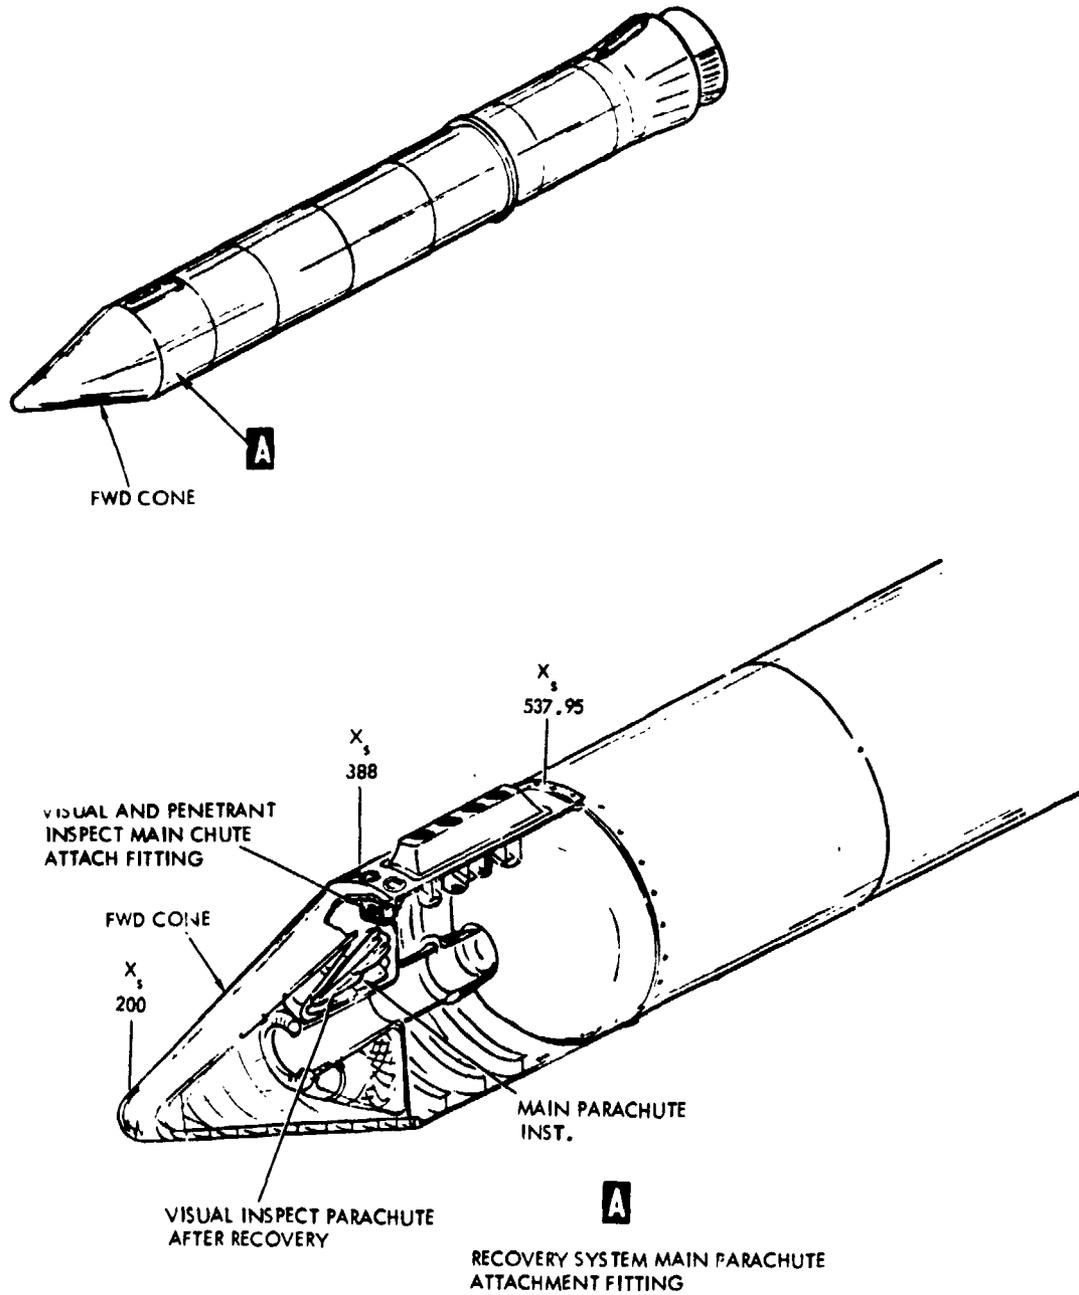
Figure 8-1. Recovery System Parachutes and Attachments

DEFECTS: Damage, corrosion and possibly cracks in the parachute attachment structure. The parachute system will be retrieved along with the SRB after water impact. If parachute separation is successfully accomplished, it is probable that the chutes will be retrieved without significant damage. If, however, entanglement between chutes or with the SRB occurs, the probability of damage to the shrouds or ribbon canopy components is high. Drying and the resultant formation of salt crystals creates a high damage potential through crystal abrasion.

maintain high moisture content conditions and direct shipment from KSC to the point of parachute refurbishment. The alternate approach would provide removal from the drum at KSC dockside facilities and immediate washing, drying, and detailed inspection for which access would be a function of the operations encompassed therein.

NDT TECHNIQUES: Inspect the parachute attach structure with fluorescent penetrant (Para. 1.5.2.1, Fig. 1-9). In the event that the parachutes are encapsulated and shipped directly to the refurbishment contractor, no further KSC inspection is required. If KSC inspection is required (assuming facilitization for the purpose) primary inspection means will be detailed visual inspection aided by selective strength testing of parachute ribbon and lines. Commercially available equipment for fabric testing would be used for this purpose.

PROCEDURE NO: 8-901, FIGURE 8-1
MAJOR ASSEMBLY: SRB FORWARD STRUCTURE, ZONE 9
SUBASSEMBLY: RECOVERY SYSTEM PARACHUTES
AND ATTACHMENTS

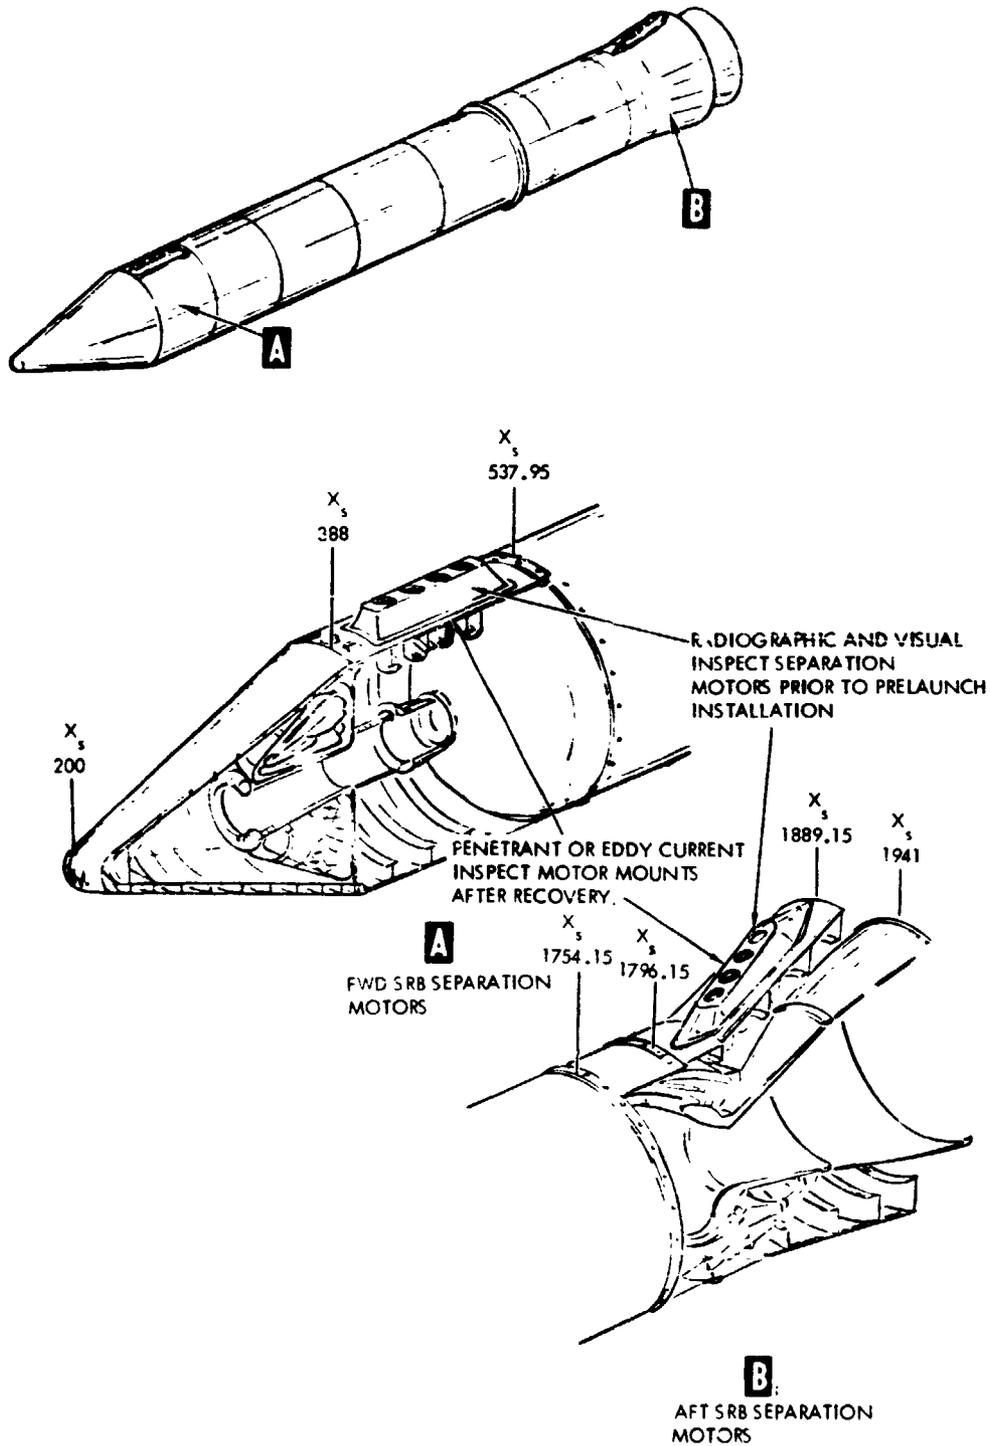
Figure 8-2. Separation Motors, Ignition Control

COMPONENT/AREA DESCRIPTION: A series of small rocket motors in the forward and aft SRB structures will be used to supply separation thrusting following SRM burnout. The number of units per SRB has not been determined, but is expected to be in the range of 8 to 10 each end of each SRB. Ignition control may be expected to be similar to that of the SRM, using a mechanical barrier system and a separate electrical power supply. The system may utilize a single safe/arm with pyrotechnic ignition trains (detonating fuse or similar) leading to the individual rocket motors. The SRB forward and aft structures will contain mounting provisions for the separation rocket motors which will be emplaced and secured individually during buildup of the SRB structures.

DEFECTS: The rocket motors may be expected to arrive in individual shipping containers, thus are probably not subject to major damage that is visually evident upon opening of the containers. Transit damage can occur, however, from very high G forces encountered in mishandling and would be noted only in evaluation of the propellant grain for cracks and separations. Similar damage could occur in the rocket motor igniter through compacting, crumbling, or separation of pyrotechnic materials to the point where ignition time delays could be encountered in firing. Damage to the safe/arm devices would be as described for the SRM. The motor mounts may experience damage due to thrust transients and/or exposure to sea water after sea-impact.

NDT TECHNIQUES: Until the effect of potential shipping damage is clearly established, the rocket motor propellant grains should be thoroughly inspected upon receipt. Radiography (Para. 1.5.6.2) should be utilized for early inspections to establish confidence in motor transportability. After development, radiography can be used for nonconformance inspection only. For all motors, the grain port should be visually inspected with a boroscope (Para. 1.5.1.3) to ascertain a void-free, crack-free condition. The igniter should be visually inspected, or subjected to radiography (Para. 1.5.6.2) on the same schedule as the rocket motor if visual inspection cannot ascertain internal defects. Visual inspection would suffice for the nozzle.

An alternate technique to propellant radiography might encompass a transportation and shock test program of sufficient magnitude to assure structural integrity of the rocket motors through a wide range of conditions coupled with inclusion of recording devices in the shipping containers that will establish levels of shock loading during transit.

Nonconforming conditions established during inspection are probably nonrepairable and would result in a Return-to-Vendor status.

<u>PROCEDURE NO:</u>	8-902, FIGURE 8-2	<u>TYPE INSPECTION:</u>
<u>MAJOR ASSEMBLY:</u>	SRB FWD AND AFT STRUCTURES, ZONE 9	(X) PREFLIGHT (X) POST RETRIEVAL
<u>SUBASSEMBLY:</u>	SEPARATION MOTORS, INCLUDING IGNITION CONTROL	(X) NON CONFORMANCE

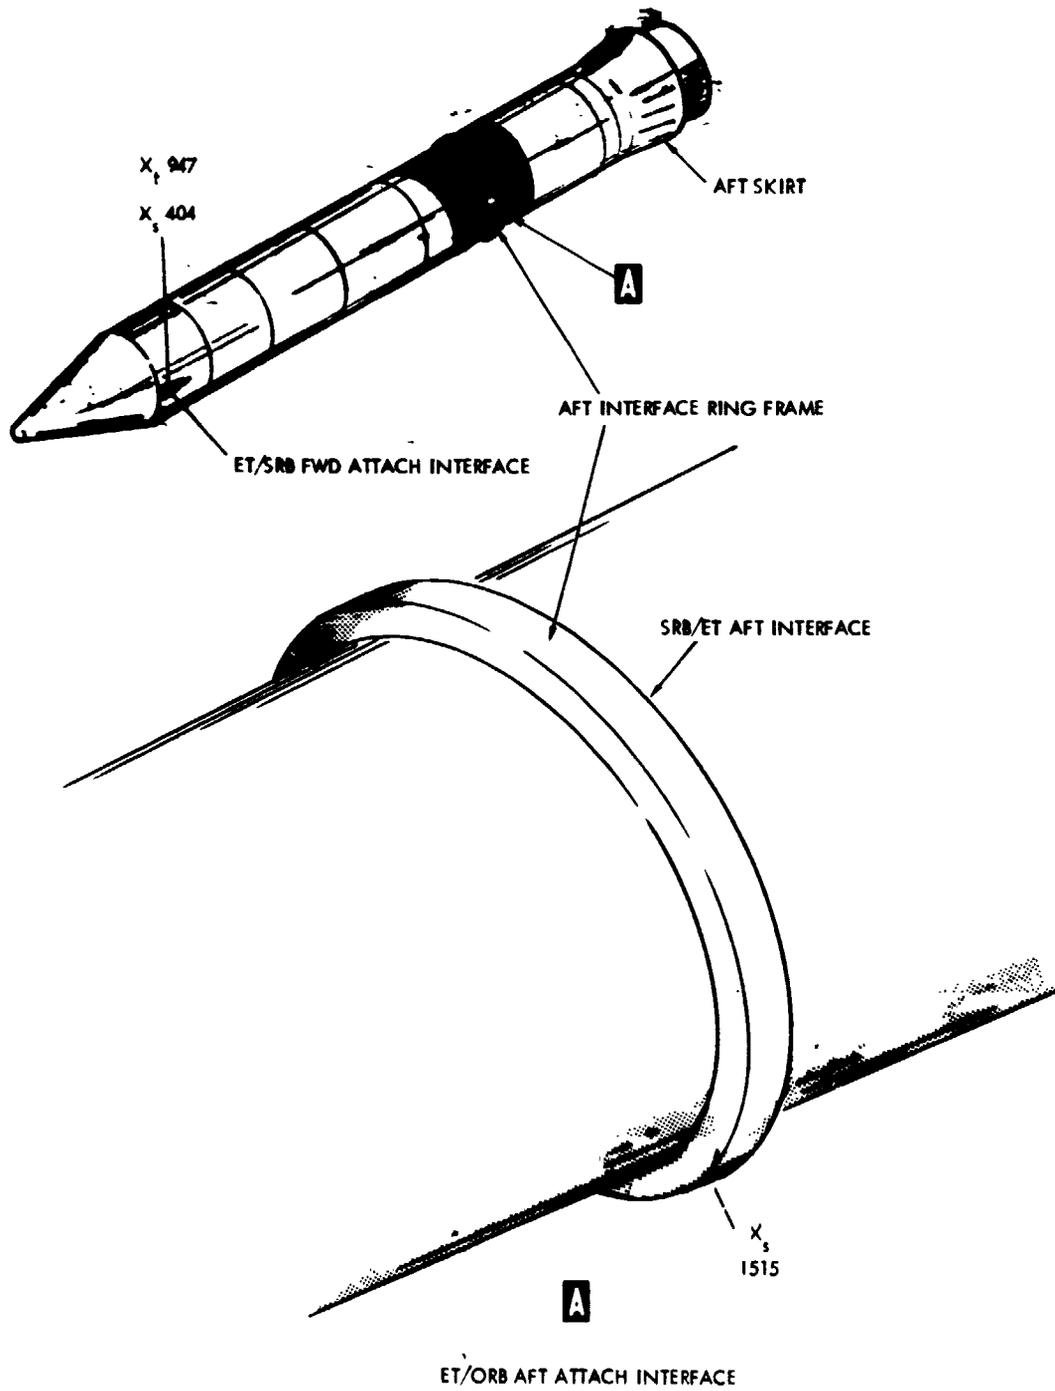
Figure 8-3. SRB Interfacing

- a. During SRM/SRB buildup, establish SRM thrust centerline in relation to SRB structural attach points and to the mobile launch platform on two SRBs.
- b. Attach interstage structures to the two SRBs, align for mating to the ET.
- c. Mate ET and align the assembly of two SRBs and one ET.

POST RETRIEVAL: Retrieved structural members should be visually examined for gross damage and returned to the supplier for refurbishment. If refurbishment is contemplated as a part of KSC operations, the items should be subjected to a remanufacturing cycle including refurbishment of protective coatings, gaging or measurement of critical dimensions, evaluation of machined surfaces and similar operations to assure acceptance to original design criteria.

PROCEDURE NO: 8-903, FIGURE 8-3

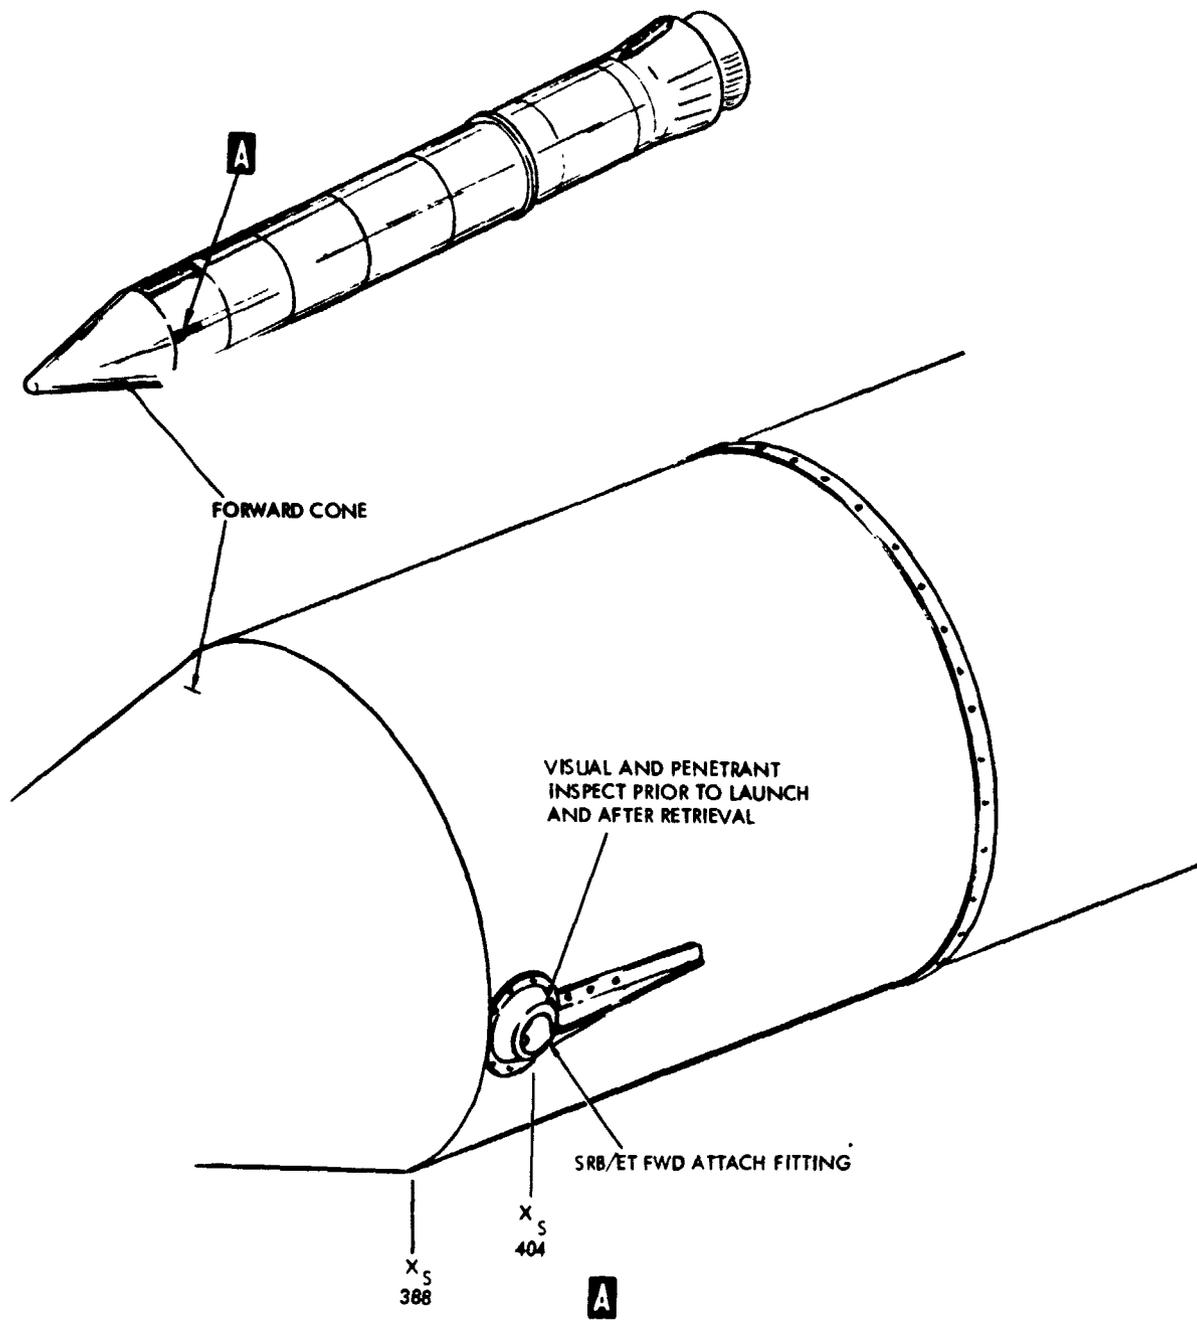
Figure 8-4. ET/SRB Forward Attach Fitting

DEFECTS: Cracks may occur in or near the attachment surfaces due to the above conditions.

ACCESS: Access is readily attained for inspection of the recovered SRB in the post retrieval maintenance shop. Access for preflight inspection is attained by the use of booms while the Shuttle is in the vertical launch attitude.

NDT TECHNIQUES: Primary: Visual and penetrant (Para. 1.5.2.1, Fig. 1-9).
Backup: Eddy current (Para. 1.5.4.4).

PROCEDURE NO: 8-904, FIGURE 8-4

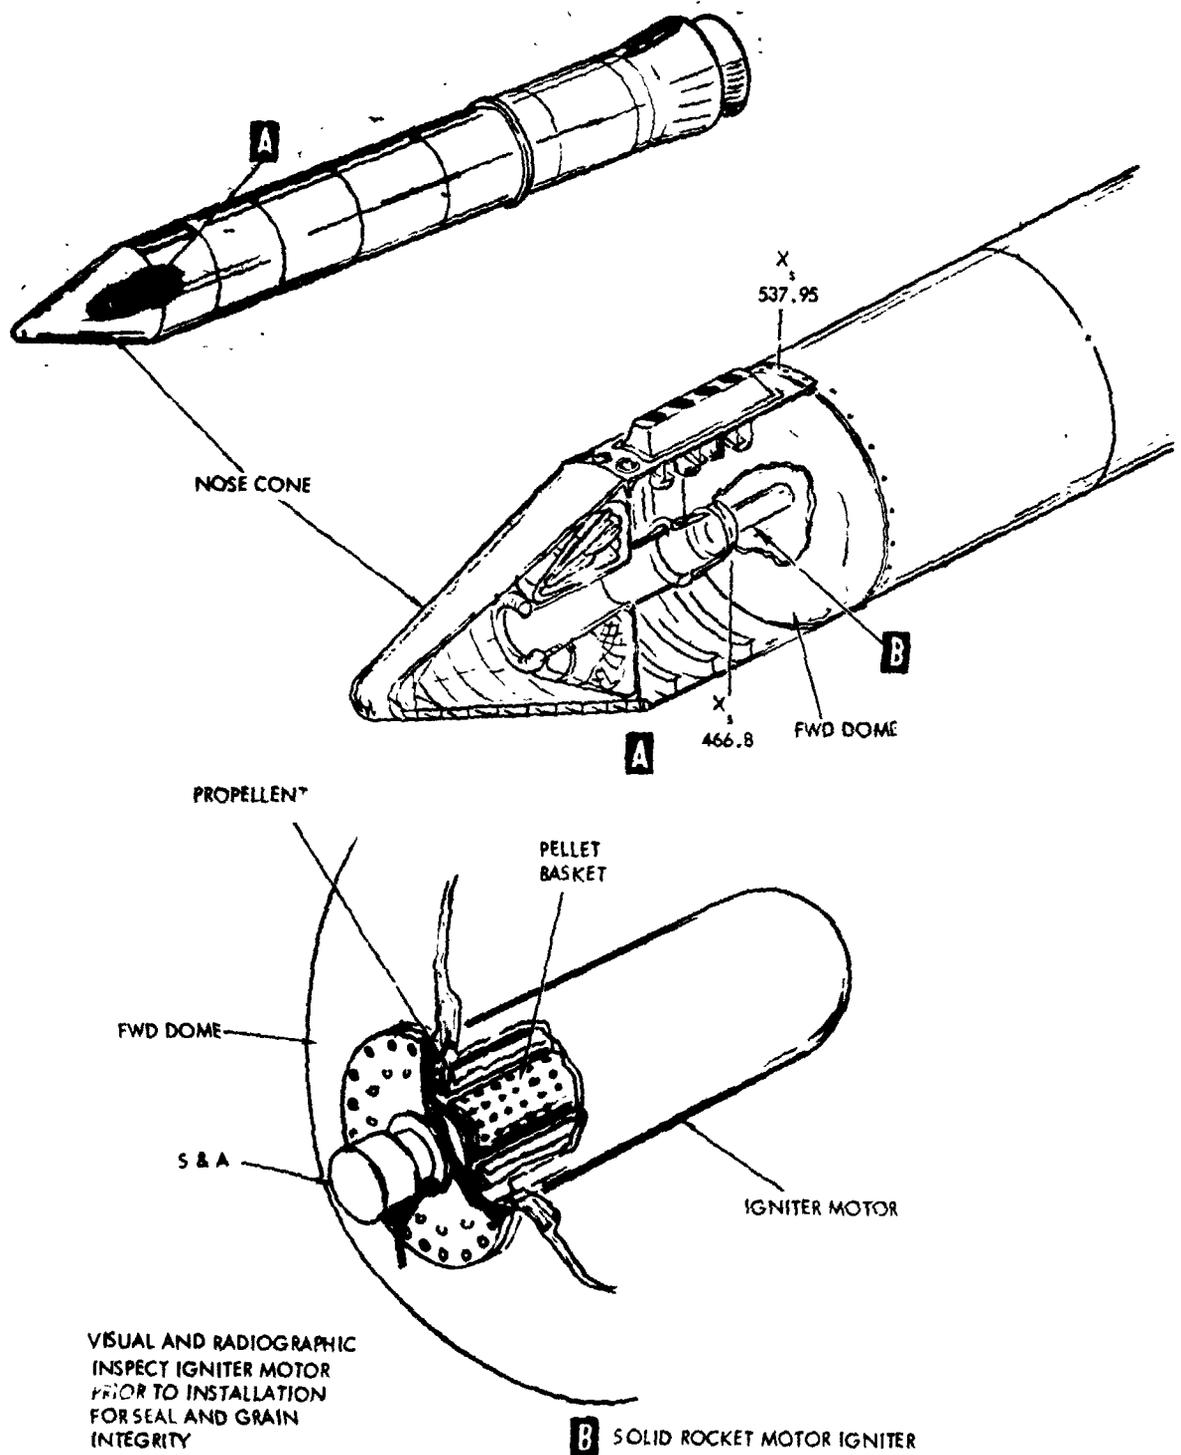
Figure 8-5. SRM Igniter

ACCESS: If the igniter is delivered assembled, only the outside of the motor case is accessible. Depending upon the type of joint and seal design, it might not be practical to disassemble the motor for inspection at the launch site.

NDT TECHNIQUES: If the igniter components are assembled at the launch site and are available for visual inspection, no additional NDT is required. If the igniter is received assembled and cannot be visually inspected, a radiographic inspection (Para. 1.5.6.2) of the assembly is recommended to inspect for presence of seals, grain integrity and condition of BKNO_3 .

PROCEDURE NO: 8-905, FIGURE 8-5

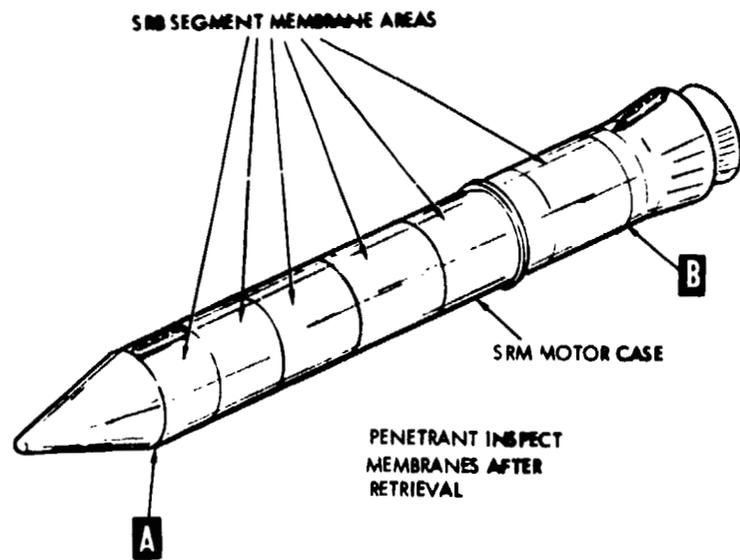
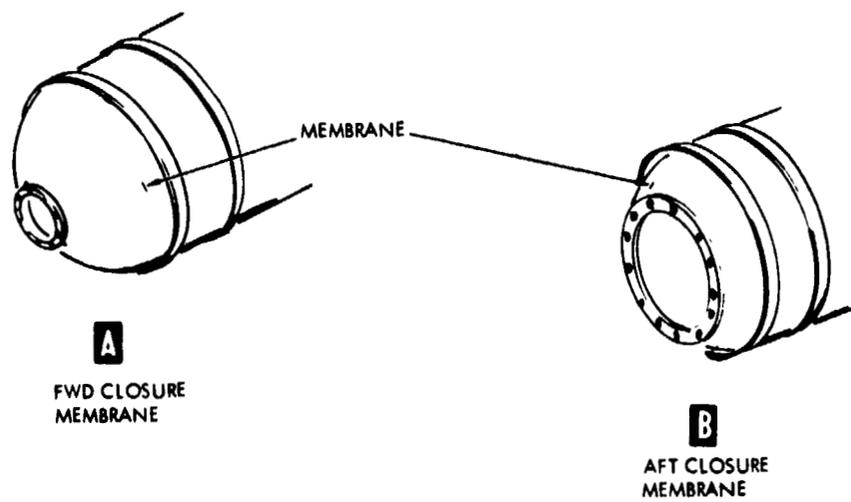
Figure 8-6. SRM Segment Membrane

2. Use an ultrasonic thickness tester (Para. 1.5.5.4) to determine membrane thickness adjacent to the damaged area .
3. After blending or repair of the damaged area, check membrane thickness at base of flaw location by ultrasonic thickness tester (Para. 1.5.5.4).
4. Penetrant inspect (Para. 1.5.2.1, Fig. 1-9) defect area to assure complete flaw removal .
5. Recoat area and test thickness of protective coating applied with magnetic or eddy current thickness gage . Type of NDI coating thickness gage will be dependent on type of protective coating used on case exterior .

<u>PROCEDURE NO:</u>	8-906, FIGURE 8-6	<u>TYPE INSPECTION:</u>
<u>MAJOR ASSEMBLY:</u>	SRB, SRM CASE, ZONE 9	(X) PREFLIGHT
<u>SUBASSEMBLY:</u>	SRM SEGMENT MEMBRANE	(X) POSTFLIGHT
		(X) NONCONFORMANCE

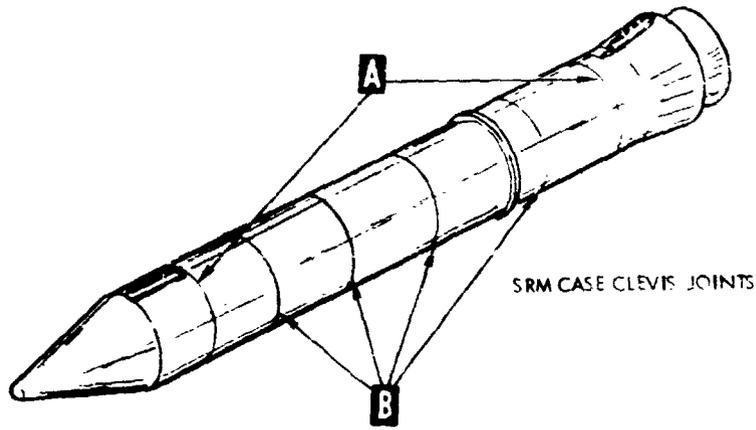
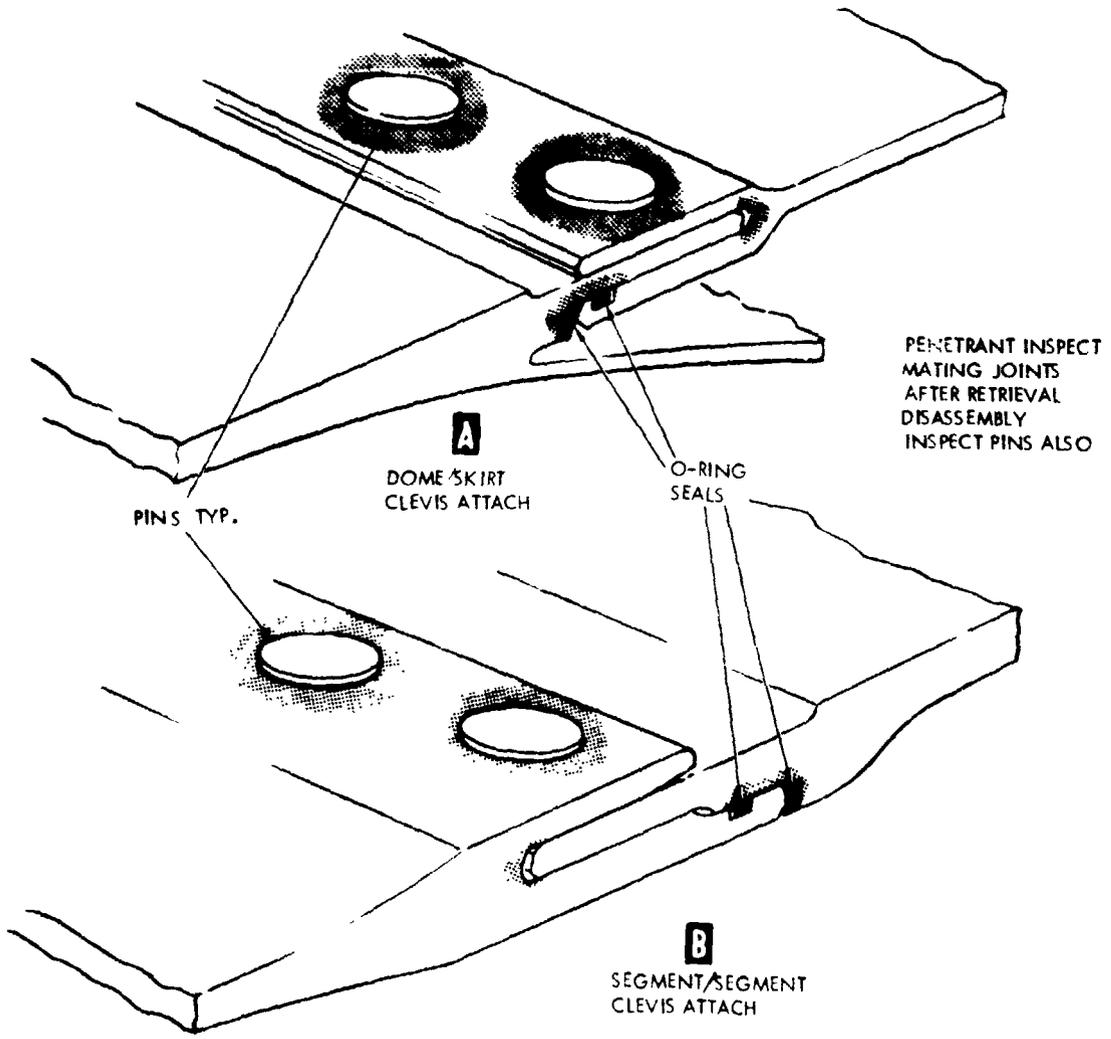
Figure 8-7. SRM Segment Clevis Joint

- 4. Penetrant inspect (Para. 1.5.2.1, Fig. 1-9) defect area to assure complete flaw removal.**
- 5. Recoat area and test thickness of protective coating applied with magnetic or eddy current thickness gauge. Type of NDI coating thickness gage will be dependent on type of protective coating used on case exterior.**

SRM CASE CLEVIS JOINTS

PROCEDURE NO: 8-908, FIGURE 8-7
MAJOR ASSEMBLY: SRB, SRM CASE, ZONE 9
SUBASSEMBLY: ASSEMBLY HARDWARE

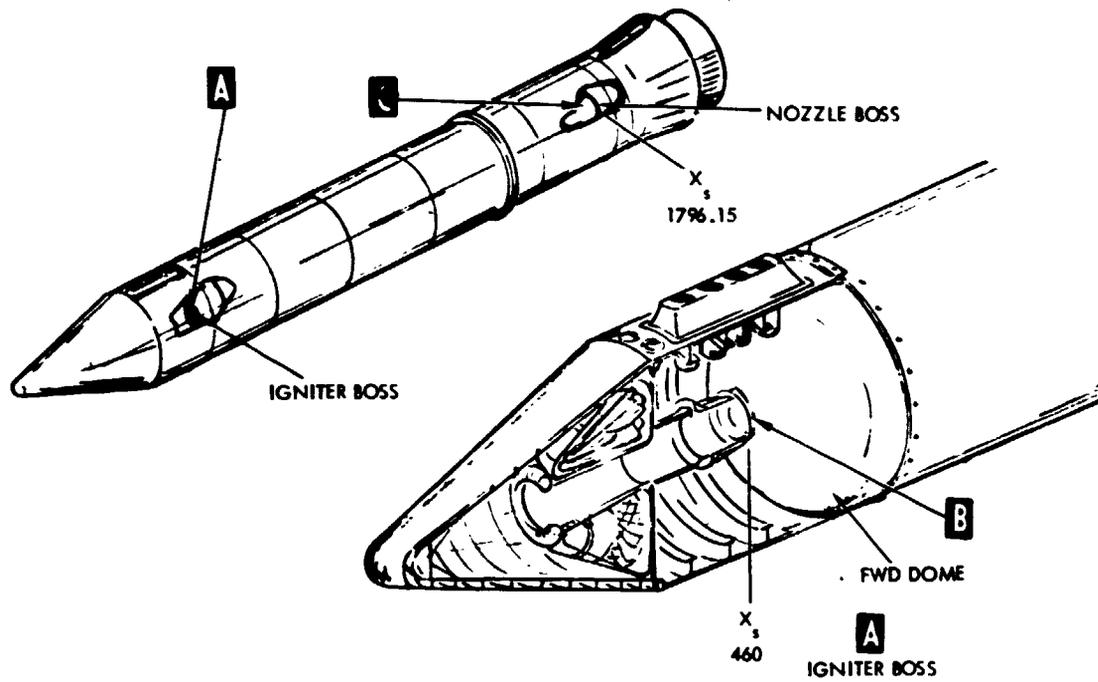
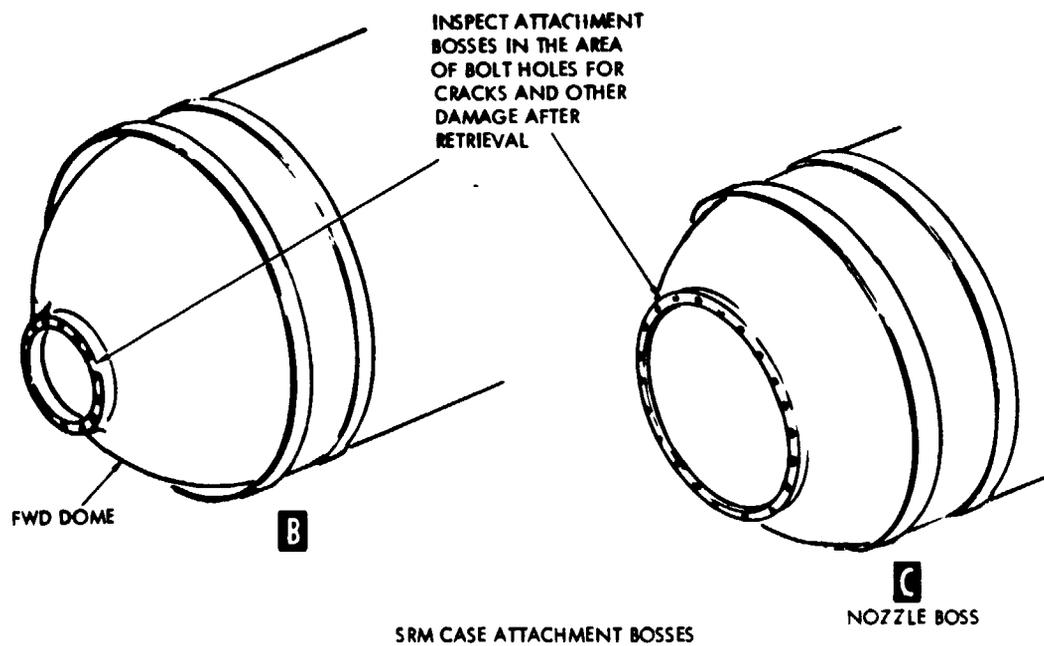
Figure 8-8. Nozzle and Igniter Attachment Boss

3. After blending or repair of the damaged area, check thickness at base of flaw location by ultrasonic thickness tester.
4. Penetrant inspect defect area to assure complete flaw removal.

<u>PROCEDURE NO:</u>	8-909, FIGURE 8-8	<u>TYPE INSPECTION:</u>
<u>MAJOR ASSEMBLY:</u>	SRM CASE, ZONE 9	(X) PREFLIGHT
<u>SUBASSEMBLY:</u>	NOZZLE AND IGNITER ATTACHMENT BOSSES	(X) POST RETRIEVAL (X) NON CONFORMANCE
